**EXISTING CONDITIONS**

**EXISTING LAYOUT AND MATERIALS**

KAISER CENTER - KAISER ROOF GARDEN  
300 LAKESIDE DRIVE  
ALAMEDA COUNTY

SHS LIBRARY OF CONCRETE  
SHEET 16 OF 18  
HISTORIC AMERICAN LANDSCAPES SURVEY  
CALIFORNIA  
CA-03

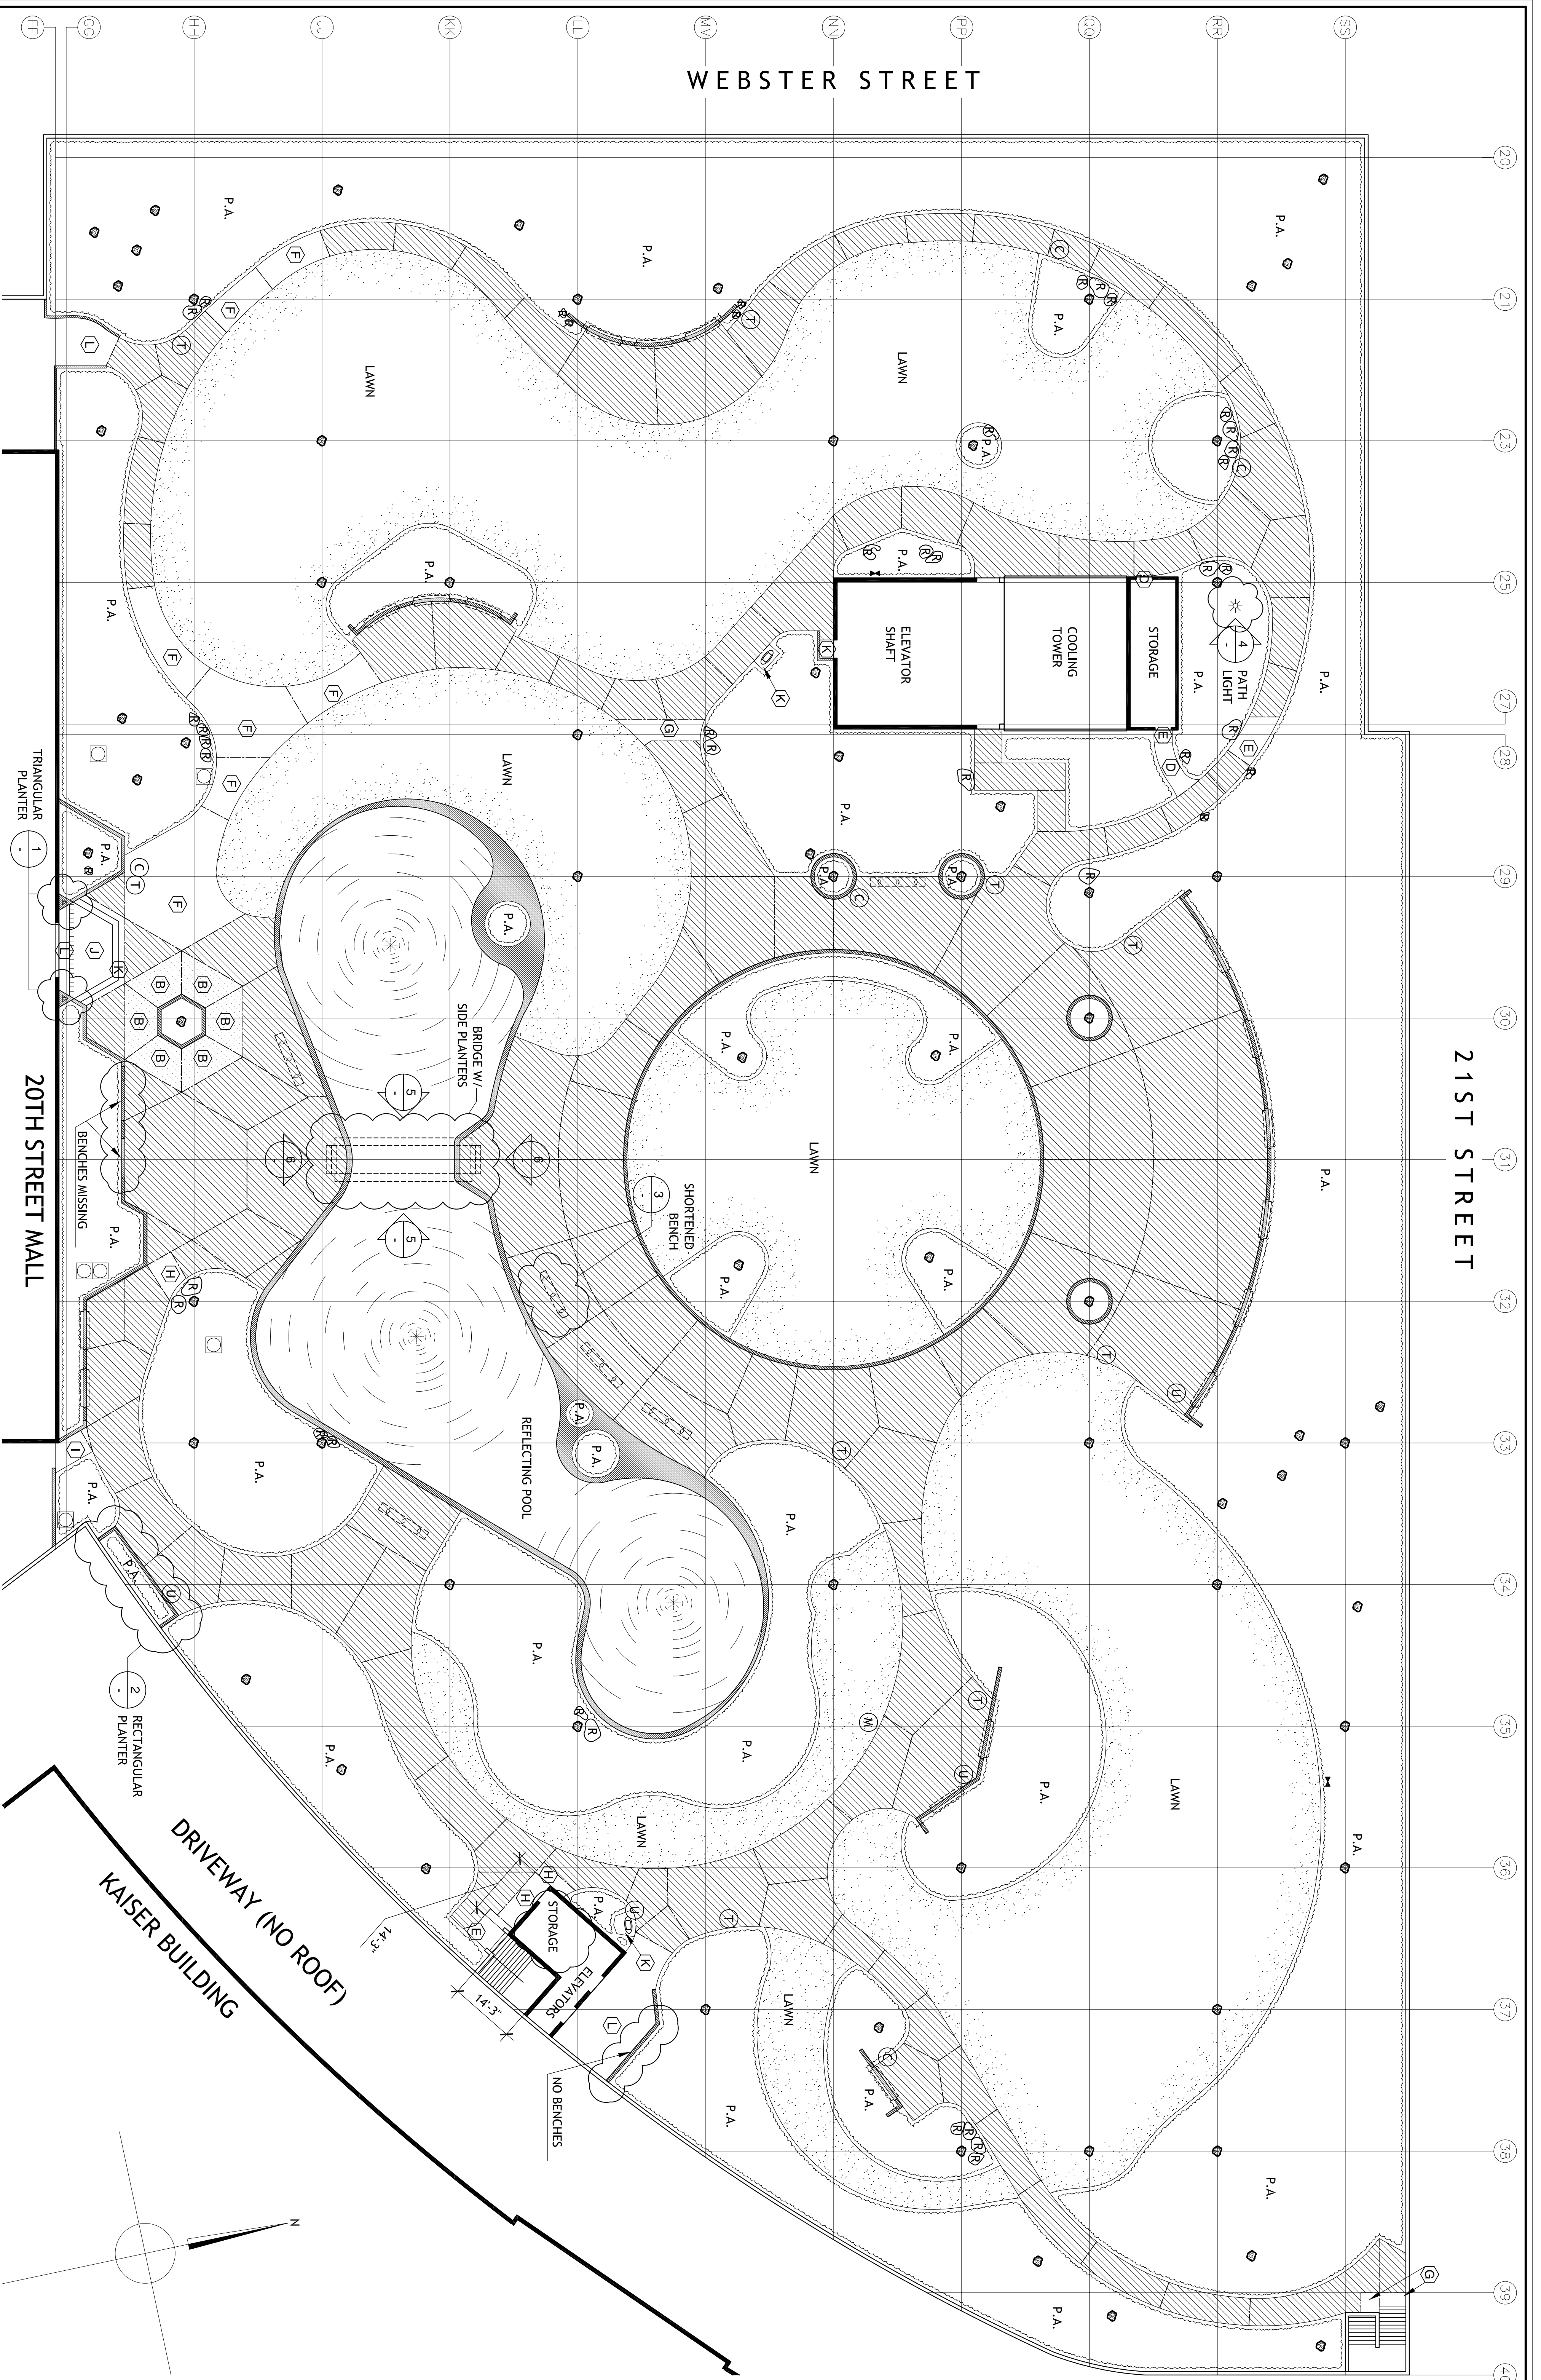
- HALS Northern California Chapter  
October 2008
- HALS Documentation Notes:  
1. Existing concrete hand bridge shown on Sheet 17 was never built.  
2. Wood rectangular bridge with side planters was installed circa 1975, and is not in the style of the original garden.  
3. Wood triangular planters were added on either side of the entrance after 1989 earthquake, to act as buffers between the building and the concrete planter walls.
